# Manhole Inspection Summary

Manhole # S69S\_\_004MH

Insp Date: **5/16/08 10:40 AM**

**Location** Address: **1700 Manor St.**

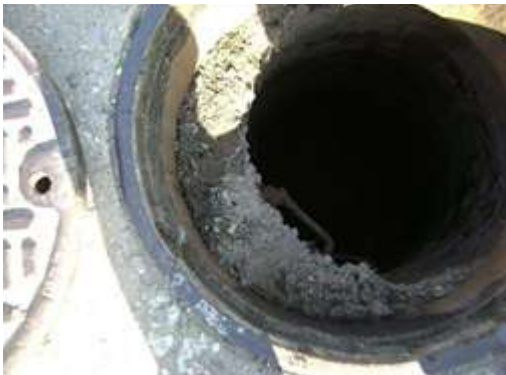
Defect 1

Offset: **3** (in.)

Offset frame defect

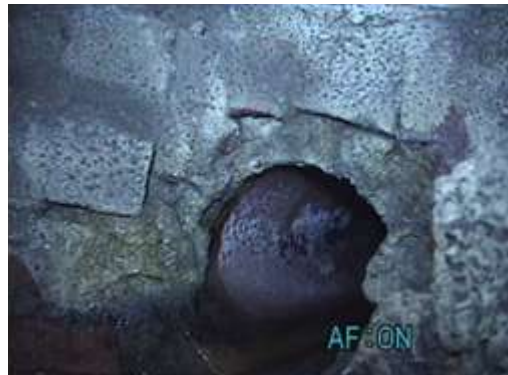
Defect 2

Pipe seal crack 11 to 1

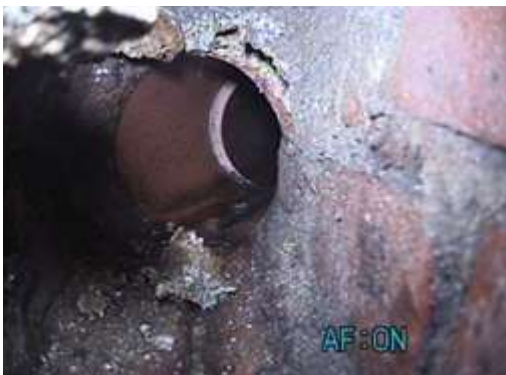
Defect 3

cracked pipe seal 12 to 2

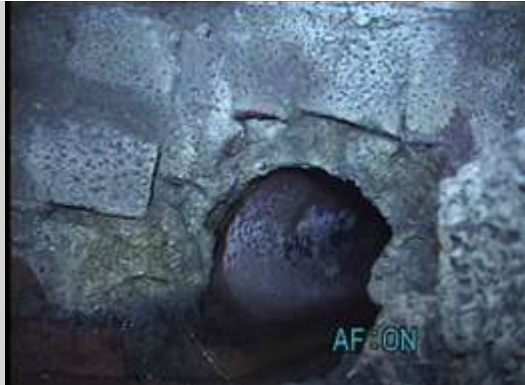
12 O'Clock Outflow

8 in. Circular Gravity Sewer  
Pipe Out @ 12 O'Clock

Pipe Height: **8.4** (in.) Rod and Bar (Angled)  
Pipe Material: **Clay** ☐ Pipe Lined  
Invert Depth: **8.83** (ft.) Flow Characteristics: **None**  
Deposits: ☒ None ☐ Mud ☐ Sludge ☐ Debris ☐ Grease  
Silt Depth: (in.) Deposits Extent:  
Infiltration: **None** Pipe Seal Cond: **Sound**

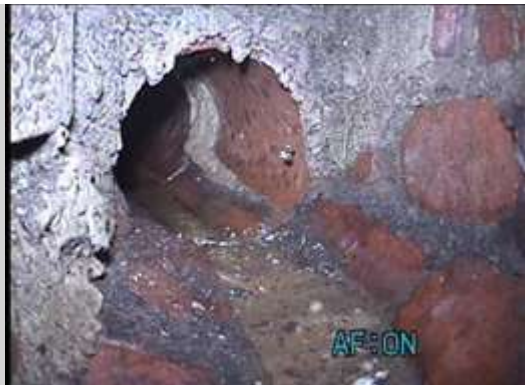
3 O'Clock Inflow

6 in. Circular Gravity Sewer  
Pipe In @ 3 O'Clock

Pipe Height: **6** (in.) Rod and Bar (Angled)  
Pipe Material: **Clay** ☐ Pipe Lined  
Invert Depth: **8.42** (ft.) Flow Characteristics: **None**  
Deposits: ☒ None ☐ Mud ☐ Sludge ☐ Debris ☐ Grease  
Silt Depth: (in.) Deposits Extent:  
Infiltration: **None** Pipe Seal Cond: **Sound**

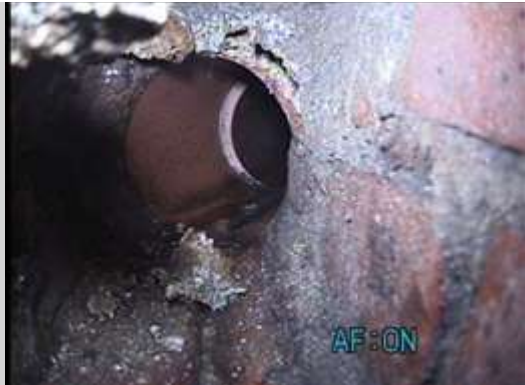
9 O'Clock Inflow

6 in. Circular Gravity Sewer

Pipe In @ 9 O'Clock

Pipe Height: **6** (in.) Rod and Bar (Angled)

Infiltration: **None**

Pipe Seal Cond: **Sound**
